Preliminary Maintenance Inspection
25,000 Gallon Elevated Legged Tank

Buyse Water Association
Coal Valley, Illinois

Inspection Performed: September 19, 2018
Reviewed by Joseph T. Hoban P.E.: October 19, 2018

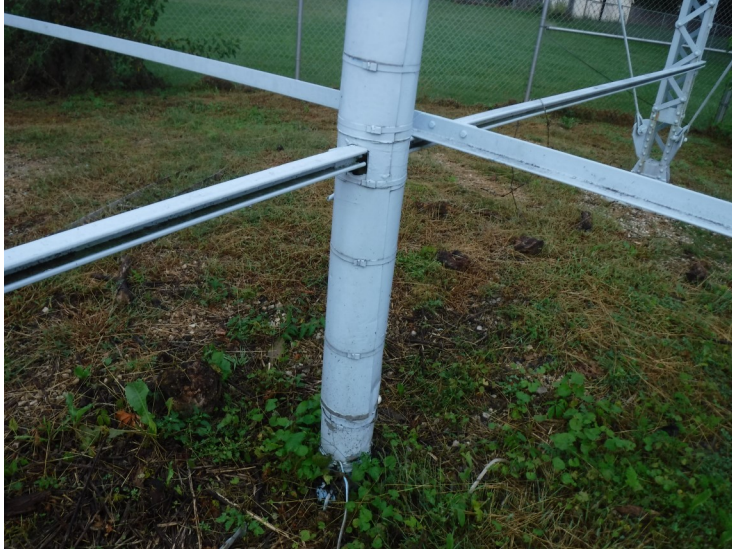
1) The fill/draw pipe routes into the ground.

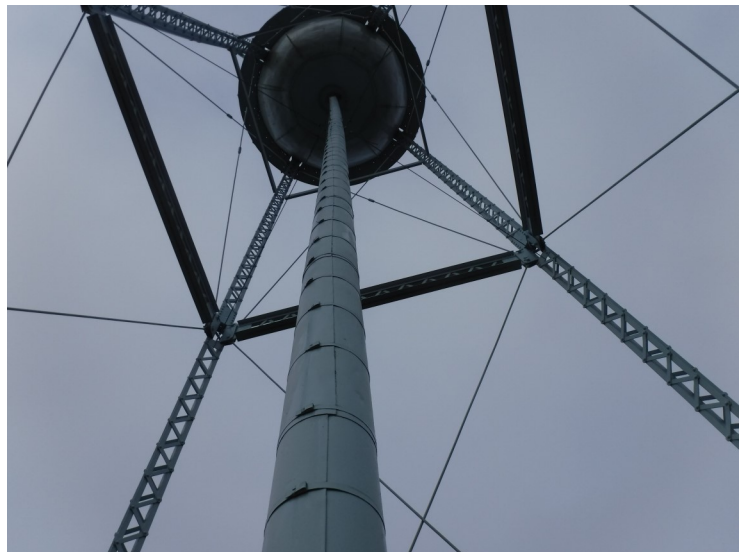
2) The fill/draw pipe is covered in insulation and aluminum jacketing.

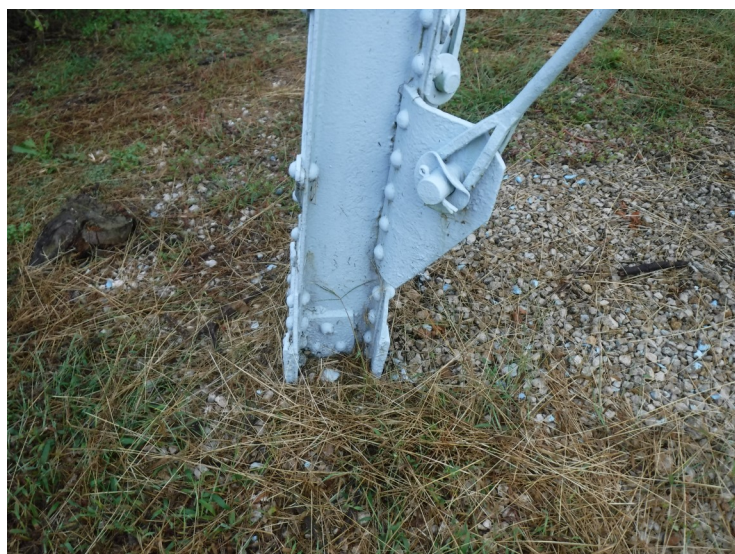
3) The leg foundations are covered with dirt and gravel.

Remove soil at the foundation to expose the top 3 inches of the foundations. Work can be performed by in-house personnel. After soil is removed the foundations can be properly inspected.

Coat the foundation to help prevent further deterioration. The cost would be incidental to exterior coating.

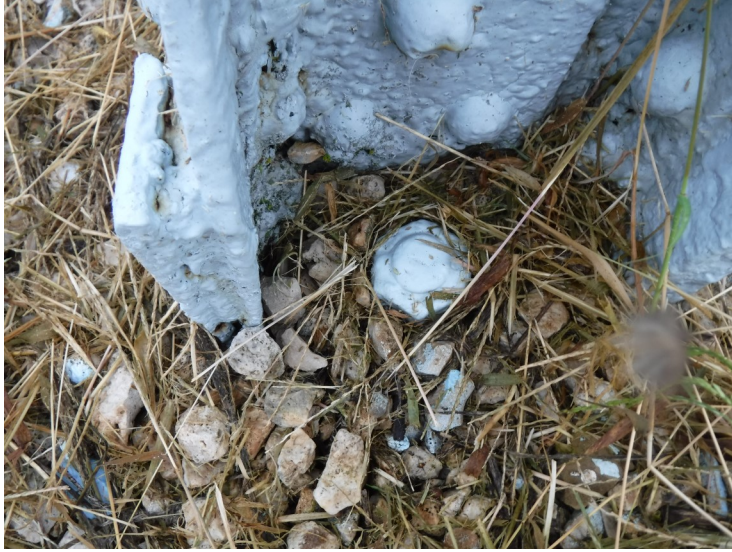
4) The anchor bolts are mostly covered in soil and gravel. The exposed coating is in fair condition.

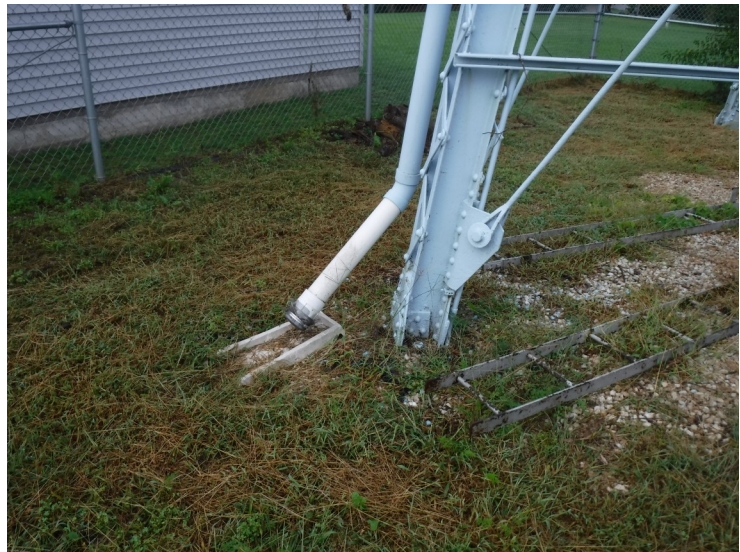
5) The overflow pipe is constructed of PVC. The PVC is in good condition.

Replace the PVC overflow pipe with a steel pipe and install a flap gate at the discharge. The estimated cost is \$8,000.

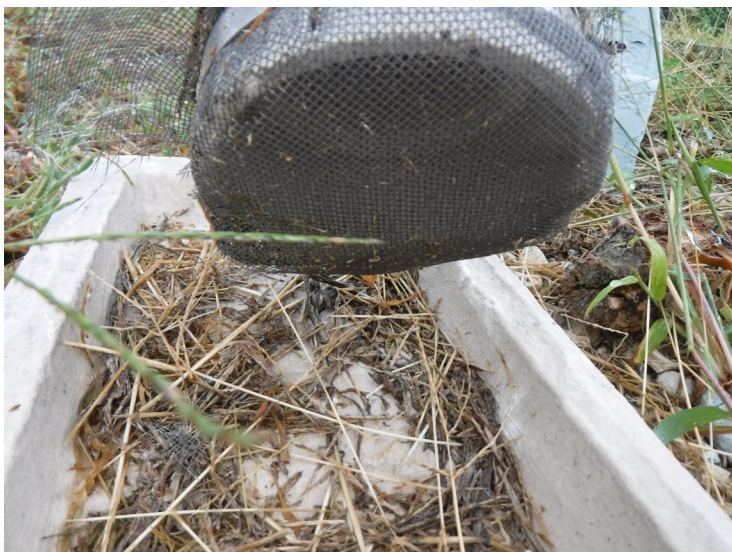
6) The overflow screen is in good condition.

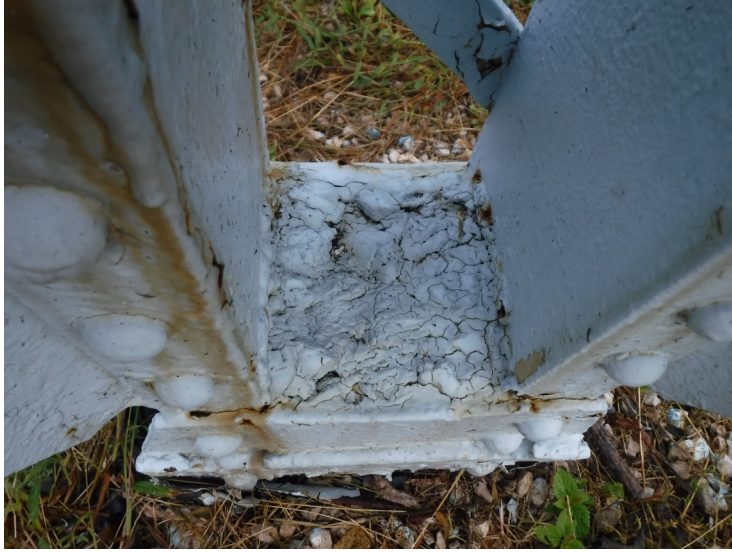
7) There is a build-up of tar that was overcoated in the bottom of the lattice legs.

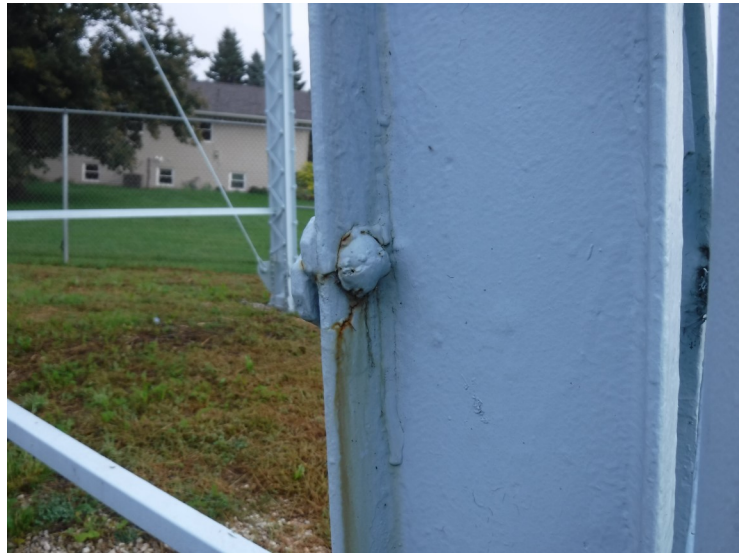
8) The leg coating is in fair condition overall with several spot coating failures.

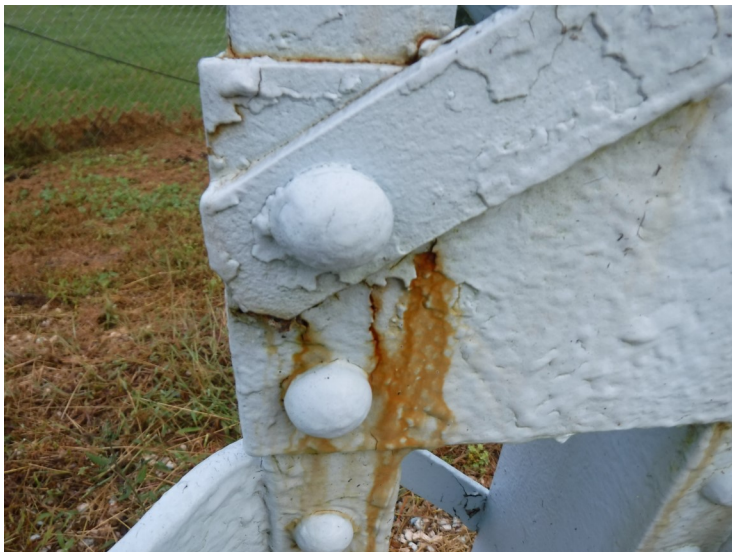
9) Spot coating failures on a leg.

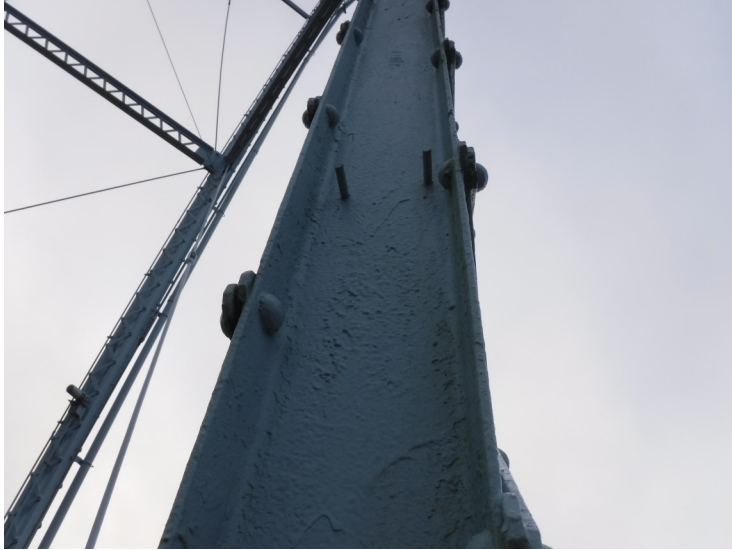
10) Same.

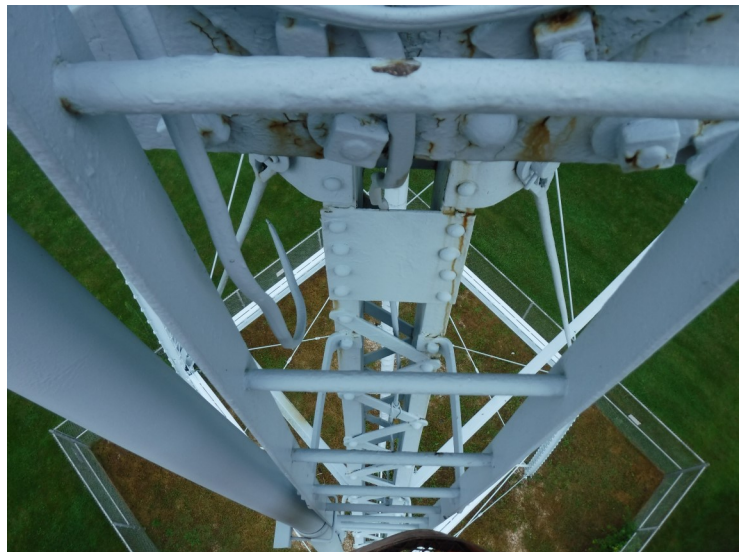
11) The ladder extends down approximately 6 feet from the balcony. The coating is in poor condition.

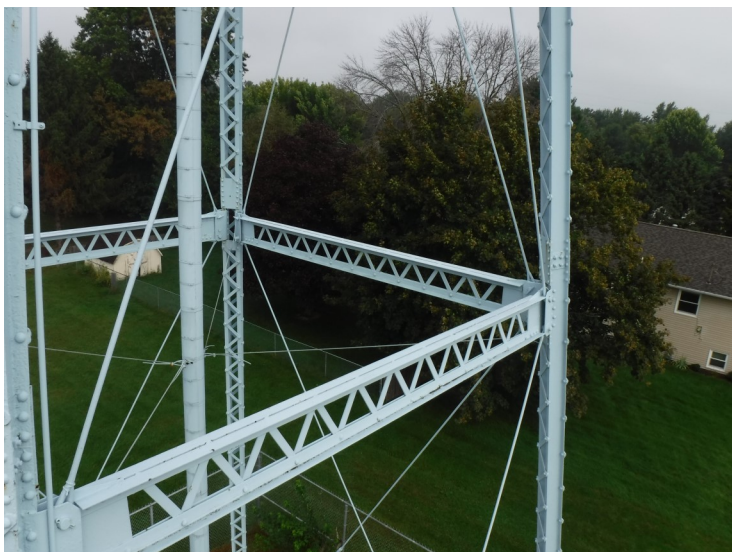
12) The coating on the struts is in fair condition.

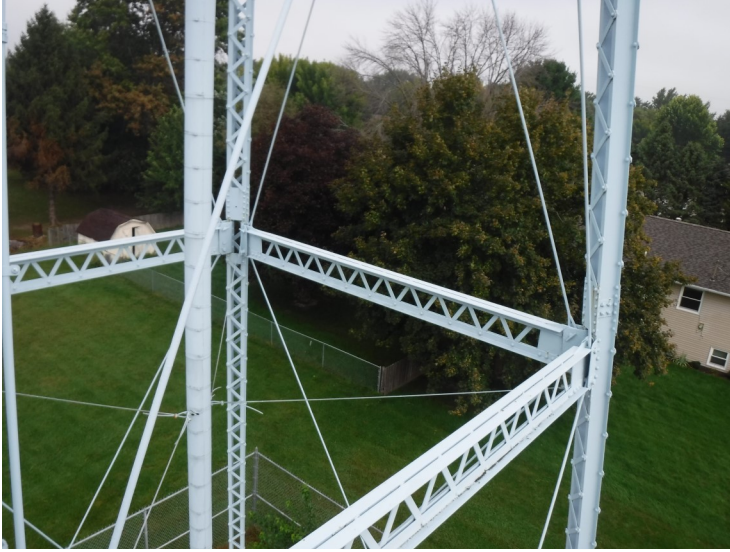
13) The sway rod coating is in fair condition.

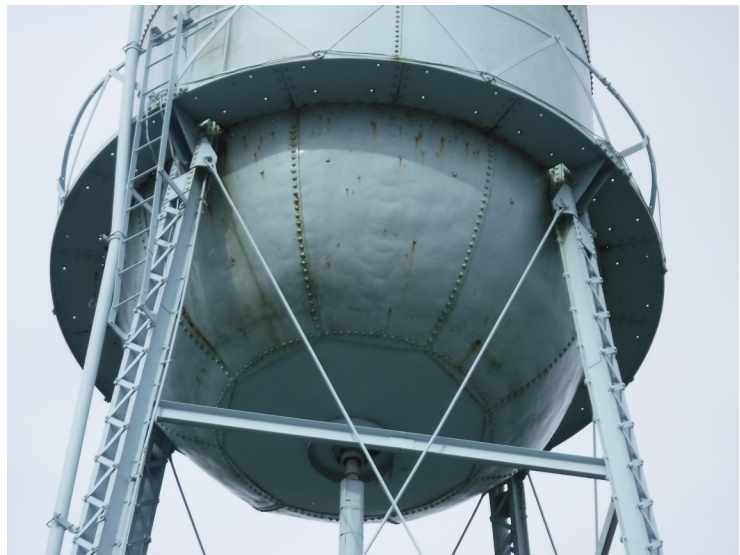
14) The bowl coating is in poor condition.

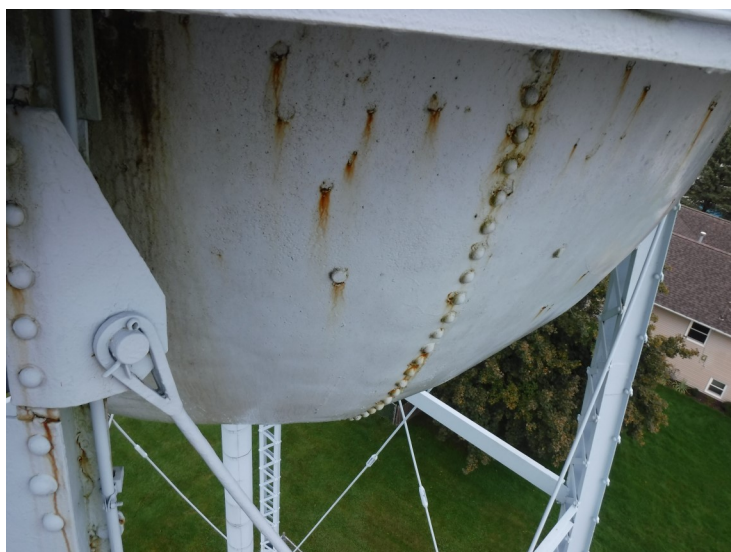
15) Spot coating failures on the bowl.

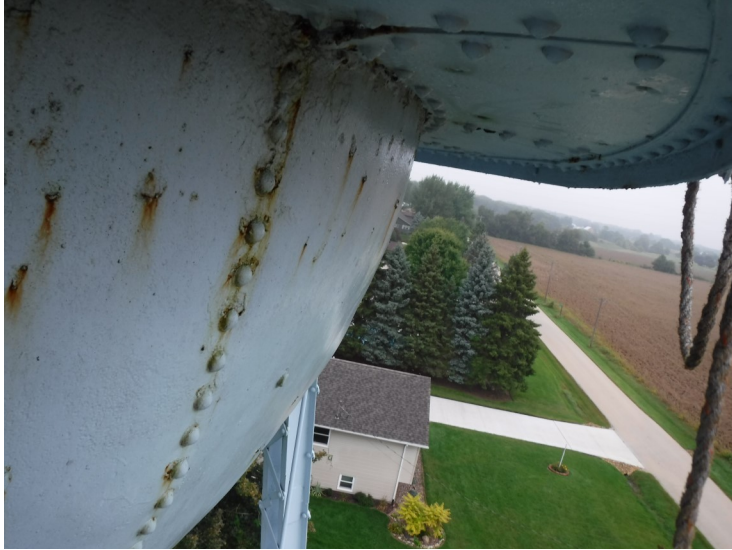
16) Same.

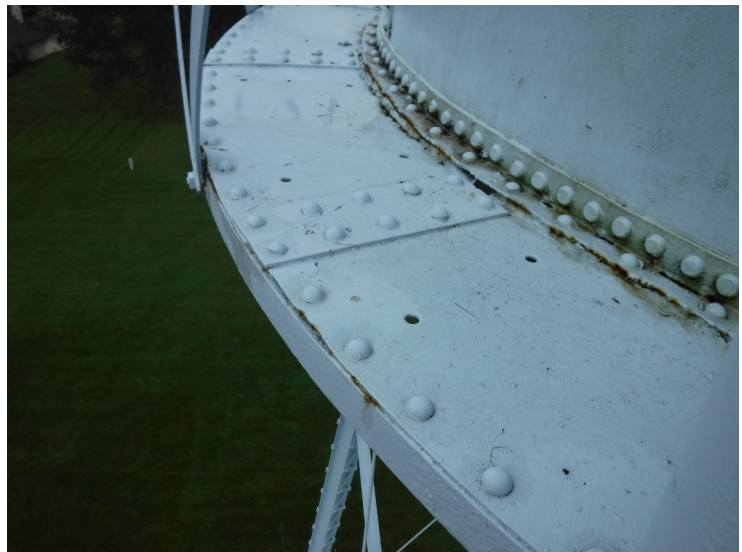
17) The balcony coating is in poor condition. There is no kickplate on the balcony railing.

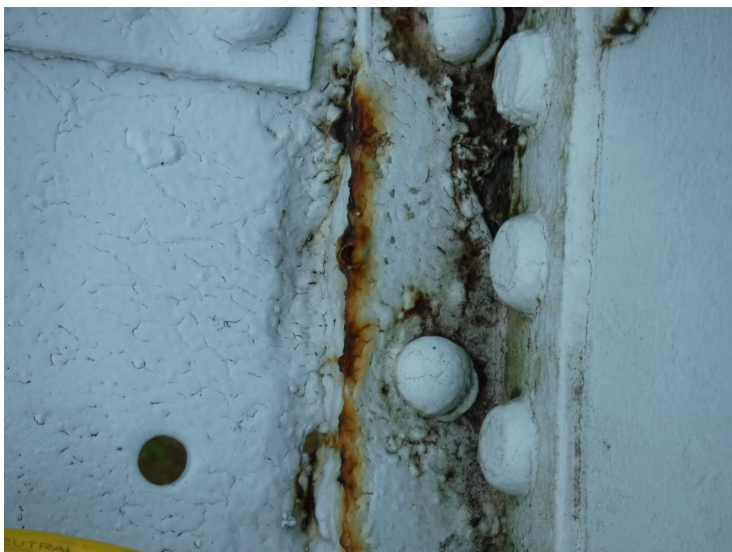
18) Spot coating failures on the balcony.

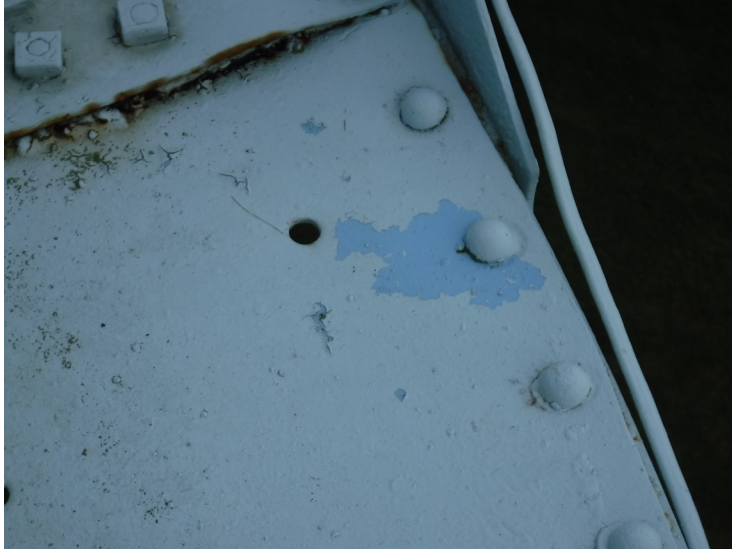
19) Coating delamination on the balcony.

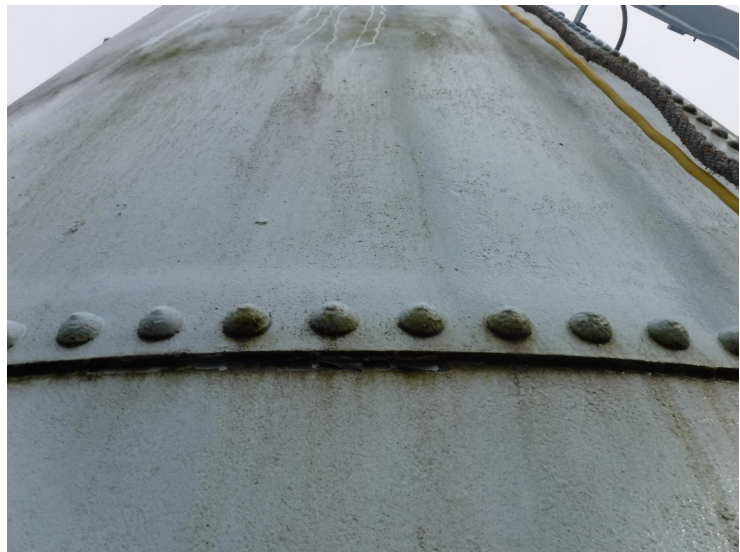
20) The sidewall coating is in fair condition overall.

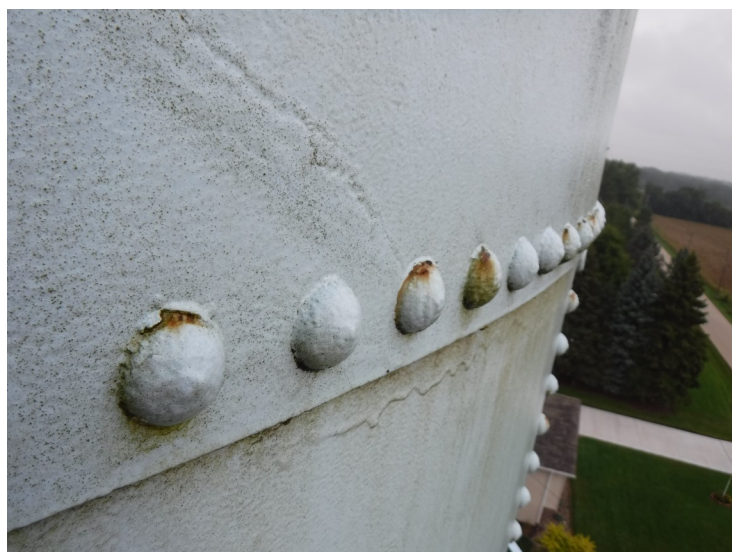
21) Spot coating failures on the sidewall.

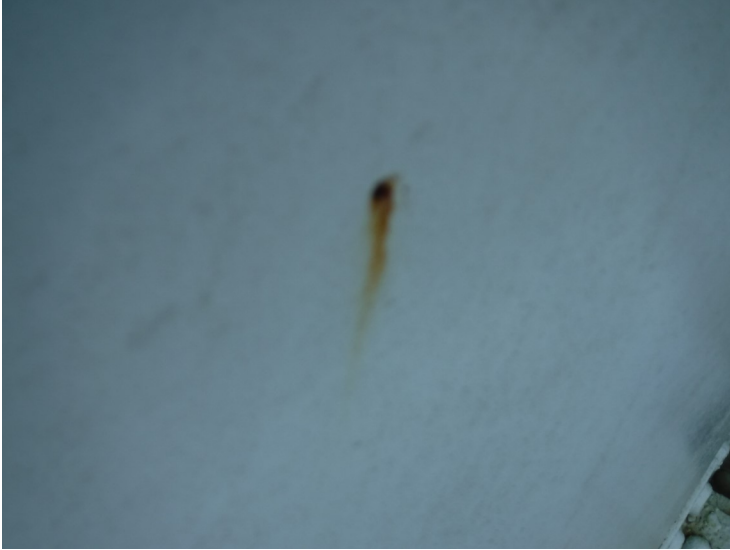
22) Same.

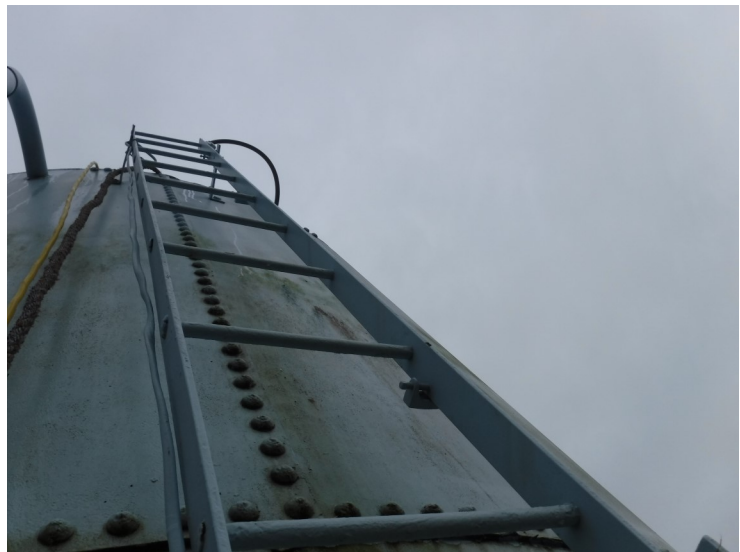
23) The sidewall ladder coating is in poor condition.

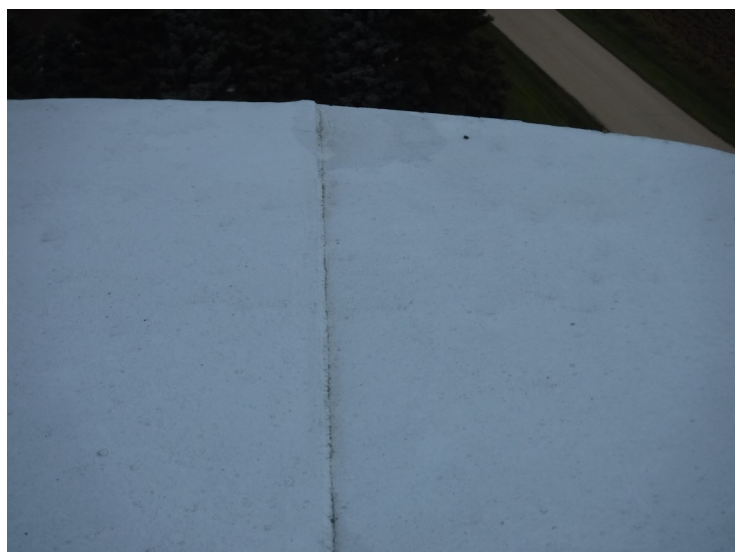
24) The roof coating is in poor condition overall.

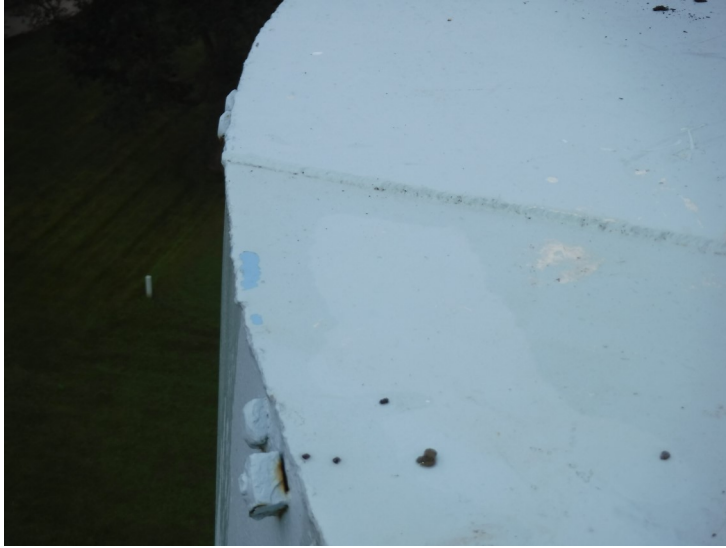
25) Topcoat delamination on the roof.

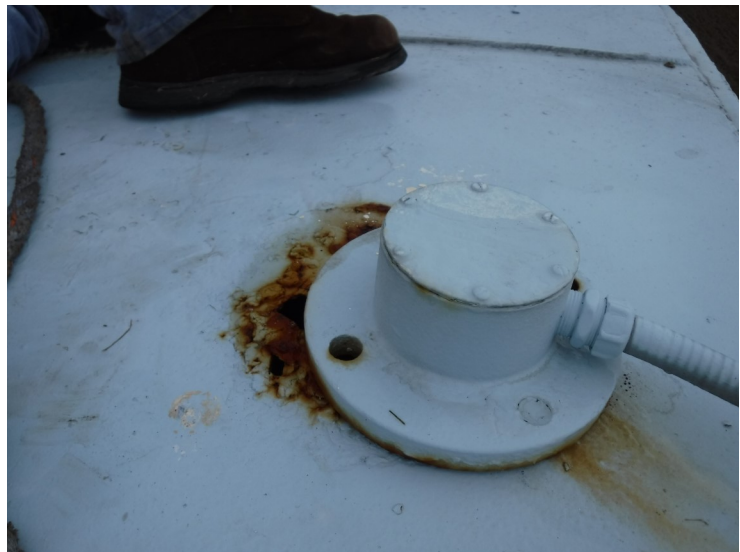
26) Coating failures on the roof. There are small holes through the roof at the penetrations.

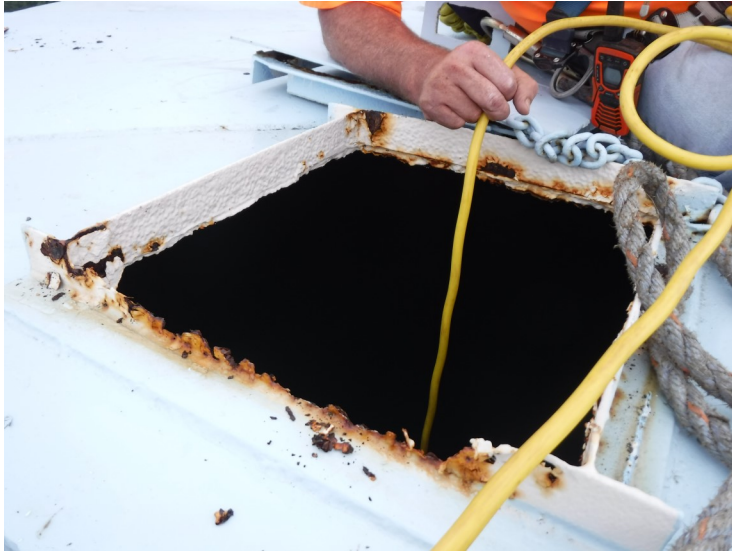
28) The roof hatch neck is severely deteriorated and the cover is no longer attached to the hinge.

Replace the wet interior roof access hatch with a new 30 inch hatch. The estimated cost is \$3,000.

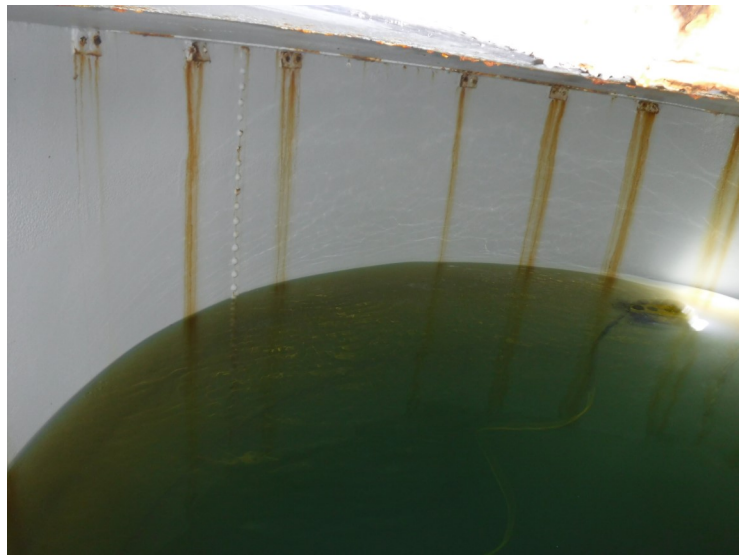
29) Coating failures on the roof.

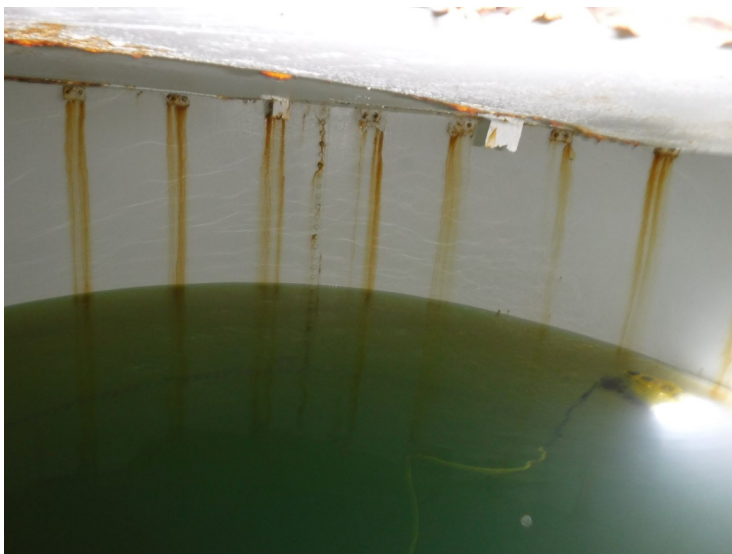
30) Same.

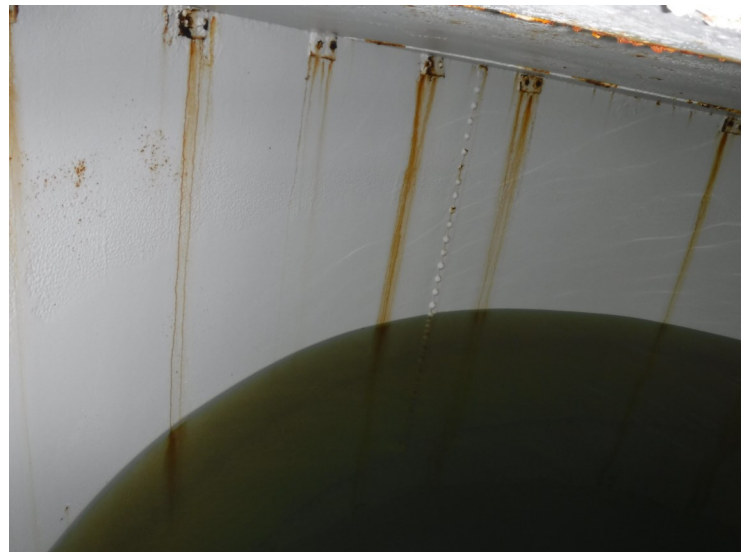
32) Coating failures on the upper sidewall.

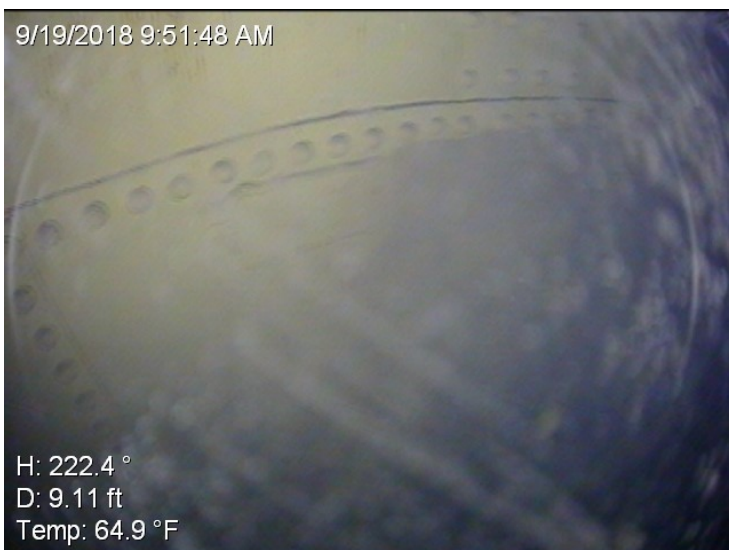
33) Spot coating failures on the sidewall.

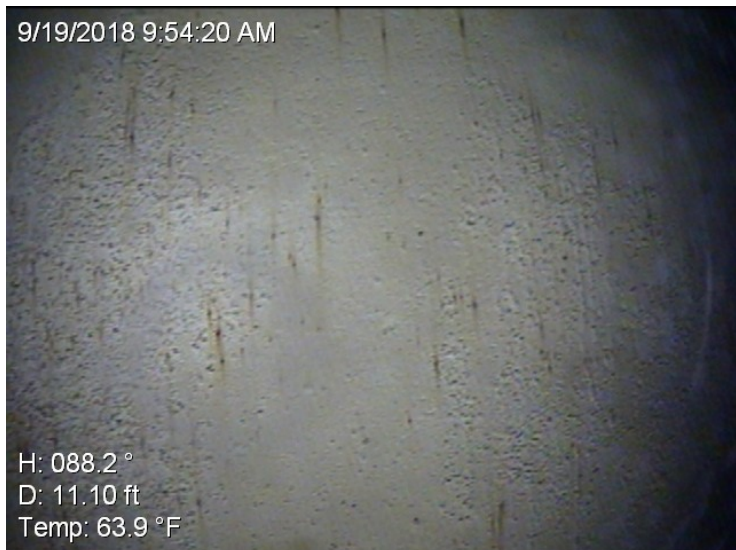
34) Same.

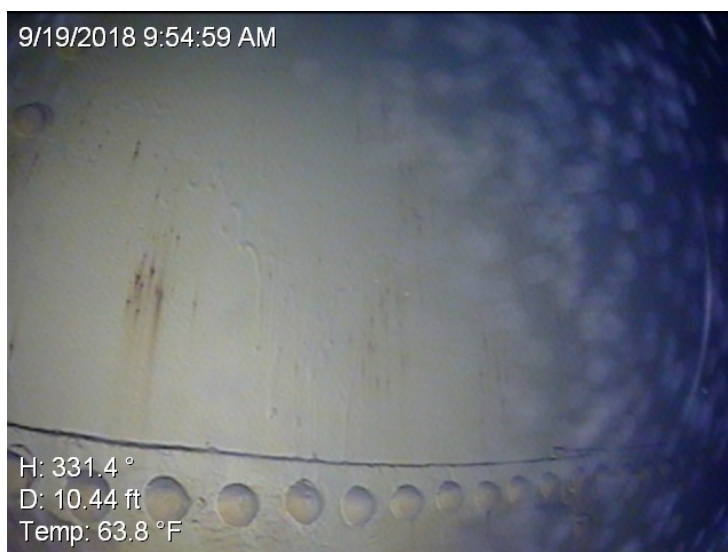
35) Same.

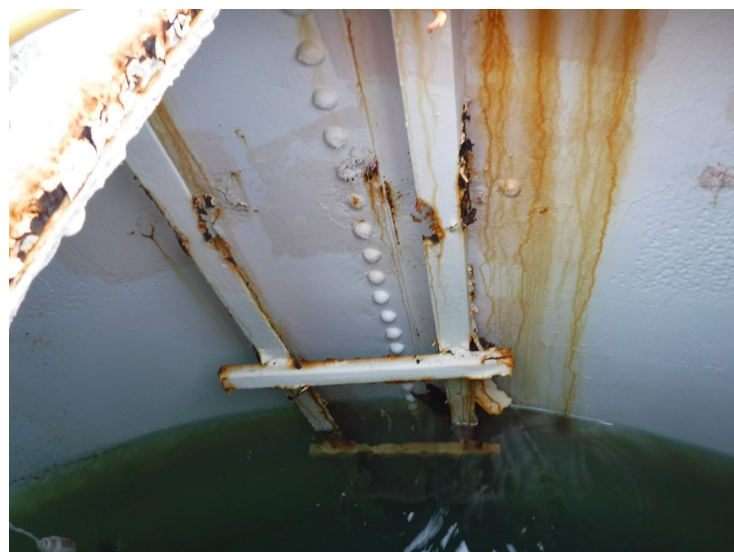
36) The top rungs are missing on the wet interior ladder.

Replace the damaged ladder in the wet interior with a new fall prevention device. The estimated cost is \$10,000.

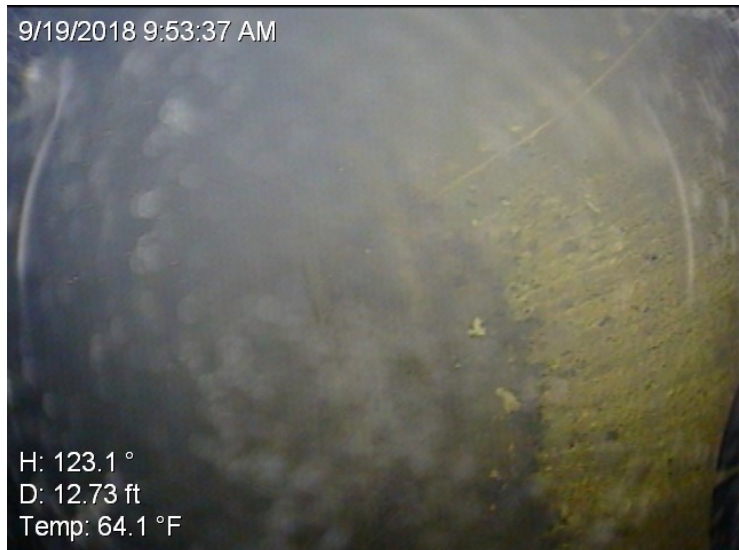
38) The bowl is covered in sediment.

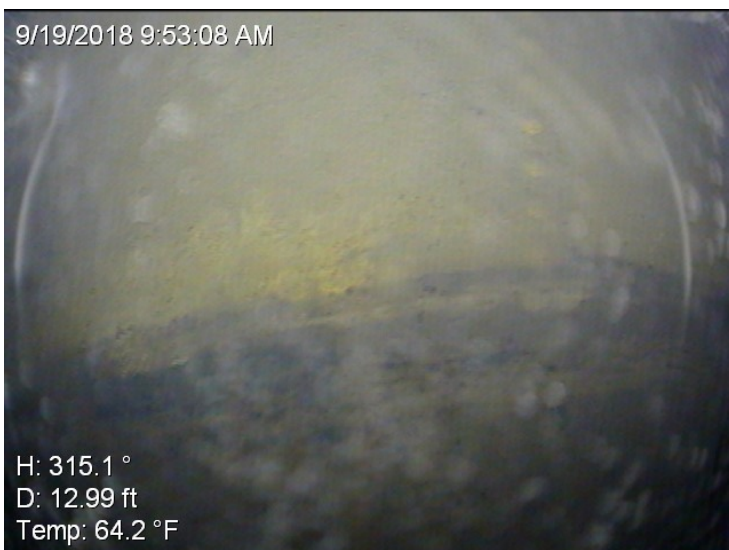
39) Same.
